Restoration have undertaken a survey of the existing façade and produced a photographic record to scale, these were then converted into a document allowing us to detail new replacement terracotta units.

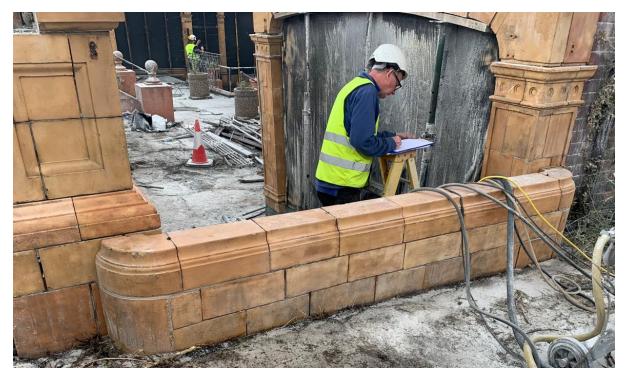
DATUM 38.00 ELEVATION N2 612 613 14 615 Orthographic elevation converted to line drawing and rectified to enable accurate rebuild in the corrected position to levels and plumb Following identity of the replacement units these were detailed in situ to ensure accuracy of replacements.

From these site details manufacture commenced. In some instances details cannot be taken and the units were sent to the manufacturer to produce maquettes for copying.

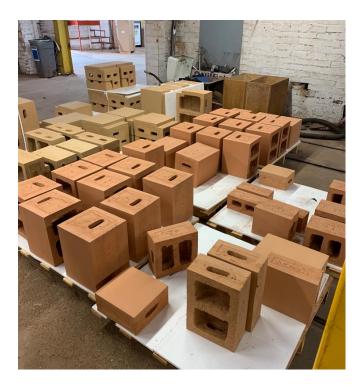
All units were numbered as per the elevatiuon drawings and photographed before packing into numbered crates and securing storing in an off site covered facility.

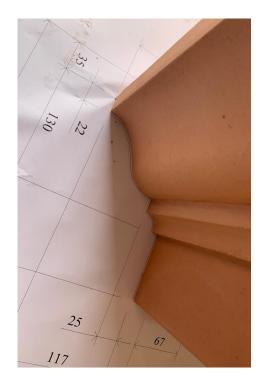
Where there were no details to copy due to elements missing being like the urns that sit on the piers, drawings were produced and plaster moulds made to which embellishments were added to ensure the scale of the new items were correct.

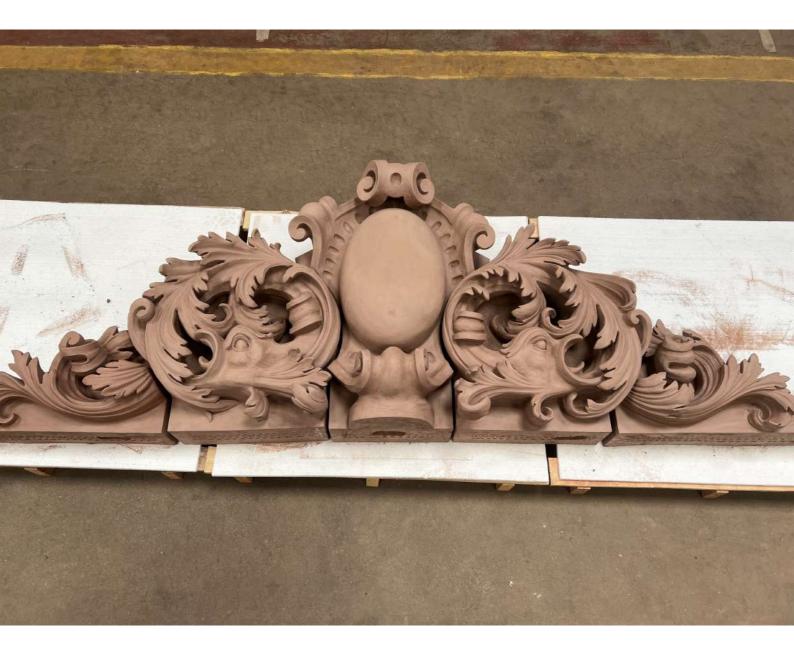
Once drawings, samples and benchmarks were approved the moulds for the units were produced in plaster

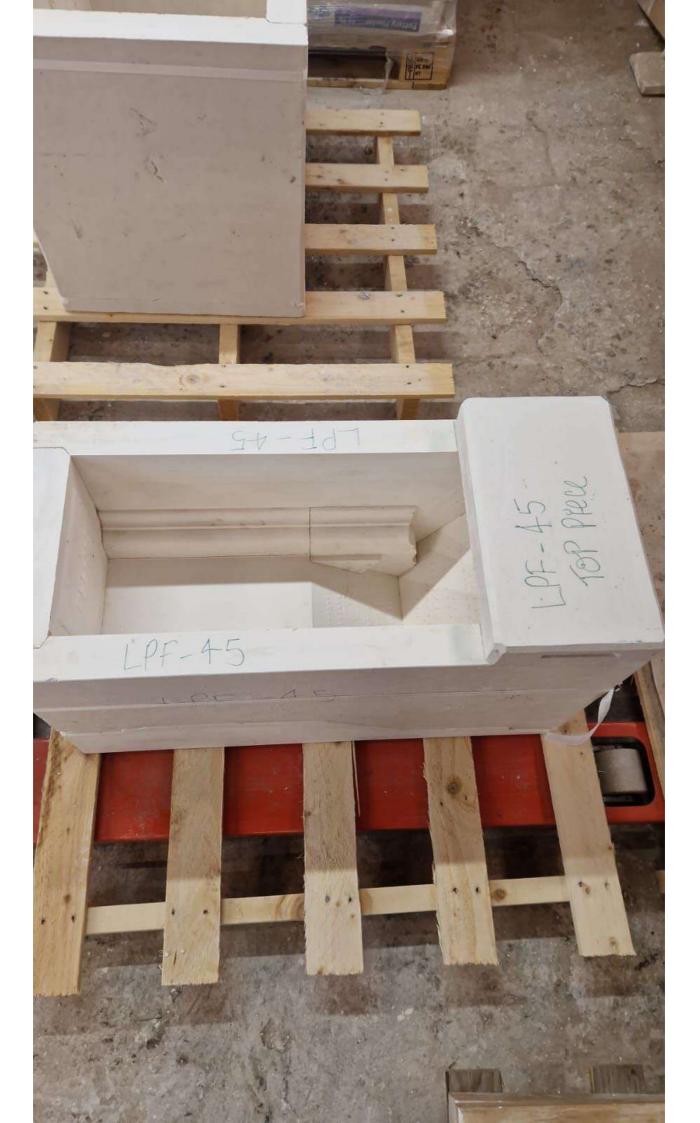
The clay is then pressed into the moulds ensuring the walls of the units are approx. 25mm thick and allowed to air dry slowly before removal and placing in the drying shed for 1 week
